Hilti CP 601S Firestop Silicone Sealant

Submission Folder

Elastomeric silicone sealant CP 601S

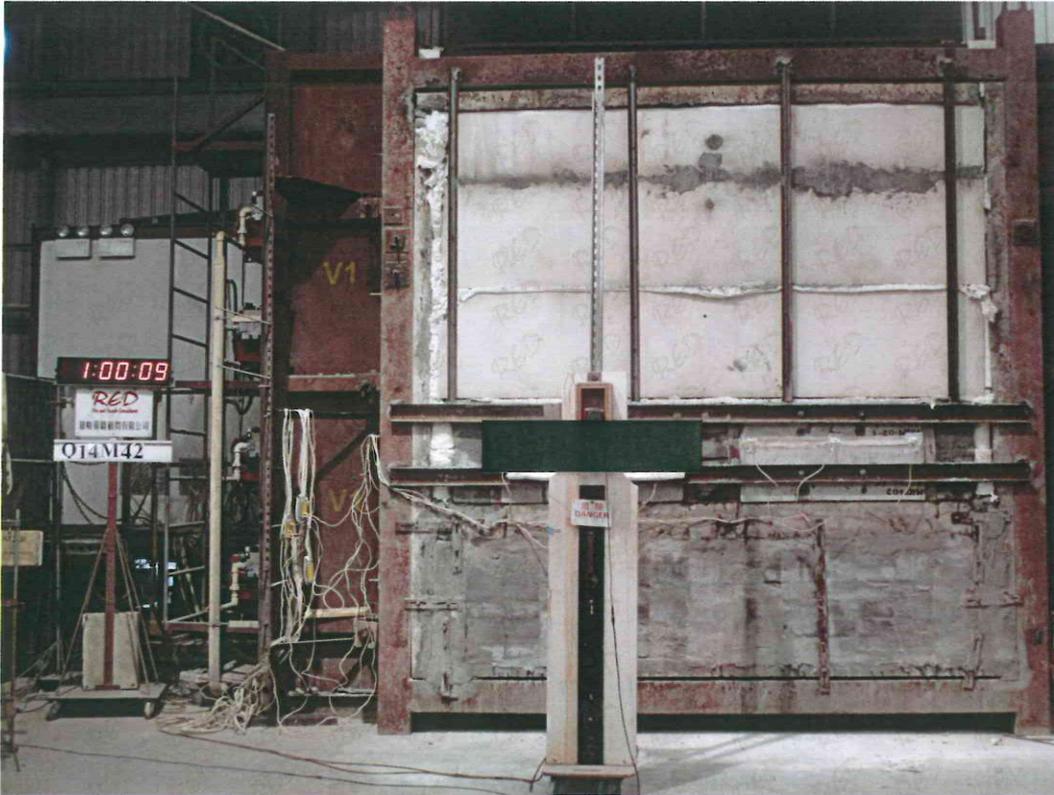
Photo 3: The unexposed face of the specimens after a heating period of 60 minutes.

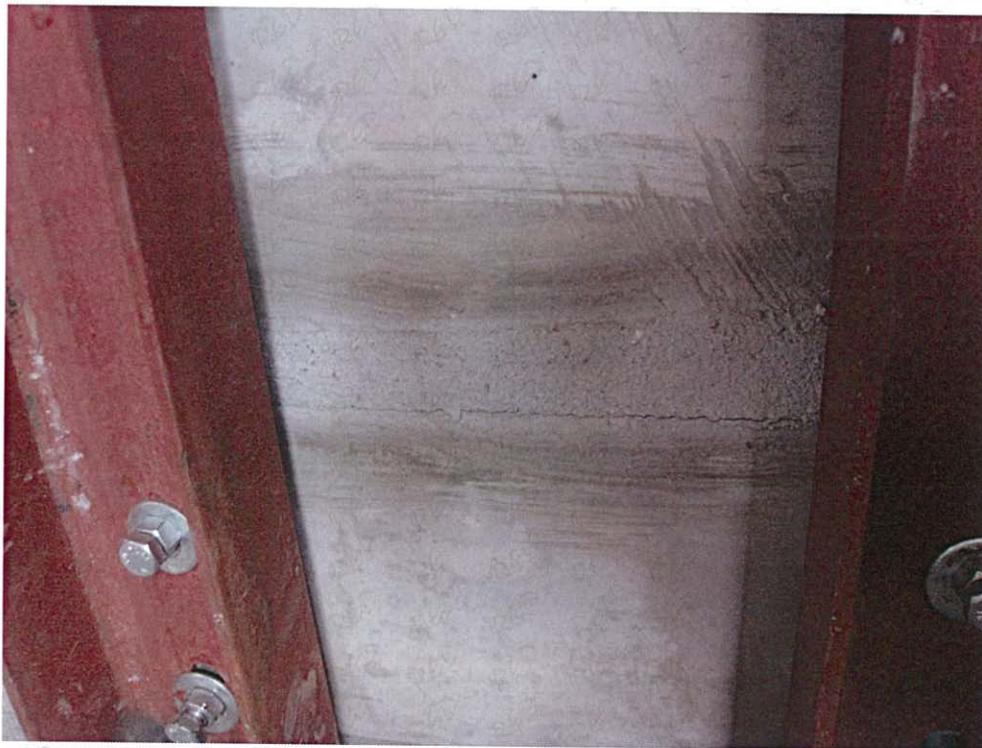
Photo 3: Specimen A after the test, the upper interface detached from the concrete substrate

The cement grout sealant detached from the upper pre-cast concrete at the beginning of the test. While the Hilti 'CP 601S' sealant complete the cycling test without visible damage.

Specimen A failed to satisfy the cyclic test.

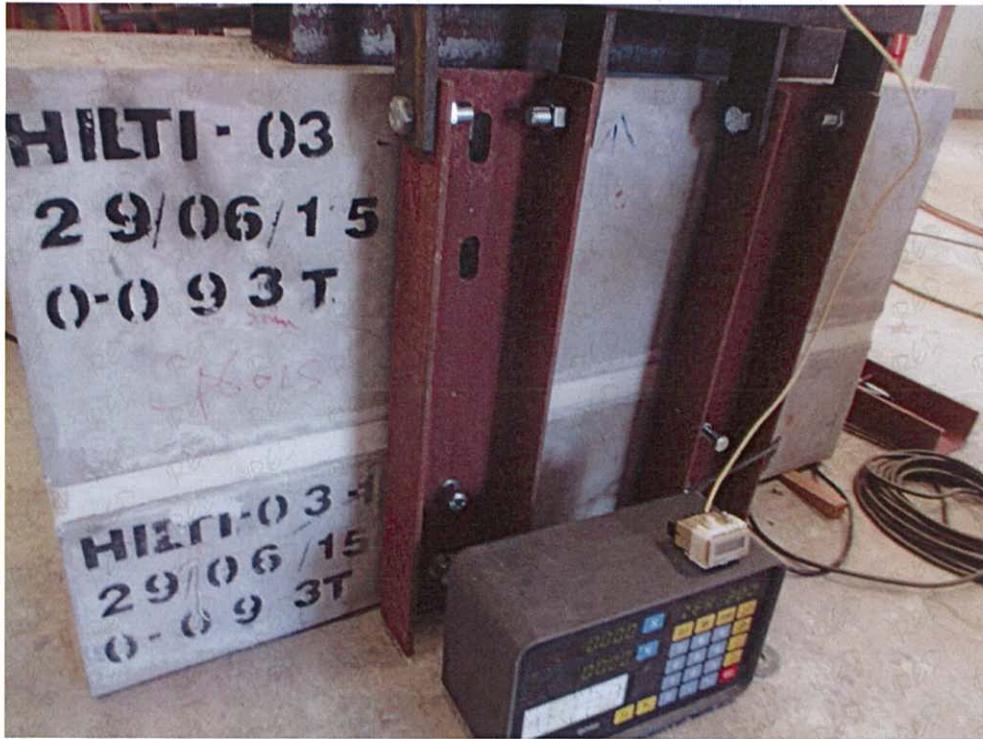
Photo 4: Specimen B before the test

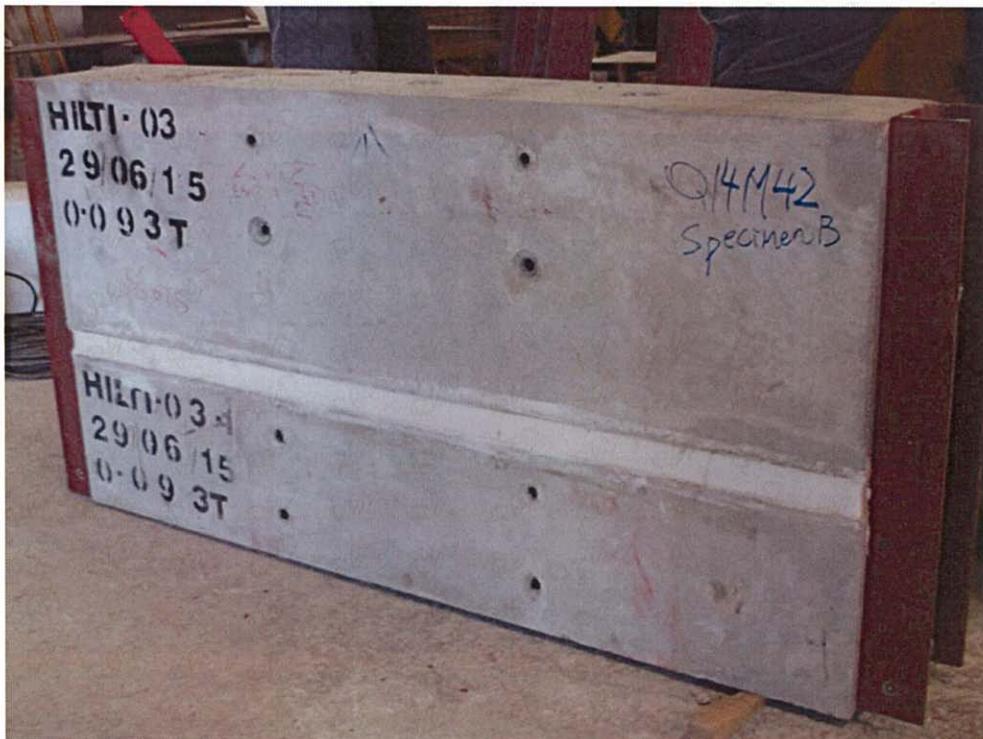
Photo 5: Specimen B after the test

The specimen complete the cycling test without deterioration observed during the test.
