# Hilti CP 601S Firestop Silicone Sealant

## Submission Folder

Product Information and Method Statement	2
Test Reports	
General	
- VOC Content	7
Top of Wall Joint	
- RED R22D26-1A Issue 1	8
- RED R15C39-1A	32
- RED R15F37	52
Piping Penetration	
- RED R23A14-1A	61
- IA23-036	81
Letters	
Government Letters	
Country of Origin	117
LEED Letter	118
Non-CFC and Ozone Confirmation	119
Material Safety Data Sheet	120
Job Reference	128

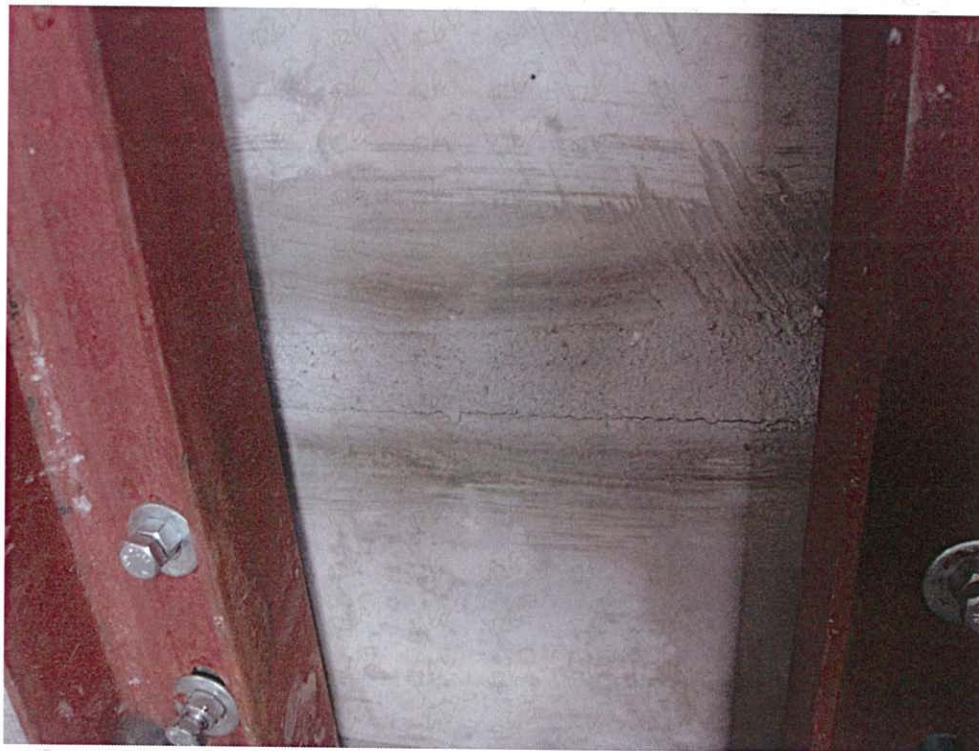
**Photo 3: Specimen A after the test, the upper interface detached from the concrete substrate**

The cement grout sealant detached from the upper pre-cast concrete at the beginning of the test. While the Hilti 'CP 601S' sealant complete the cycling test without visible damage.

**Specimen A failed to satisfy the cyclic test.**

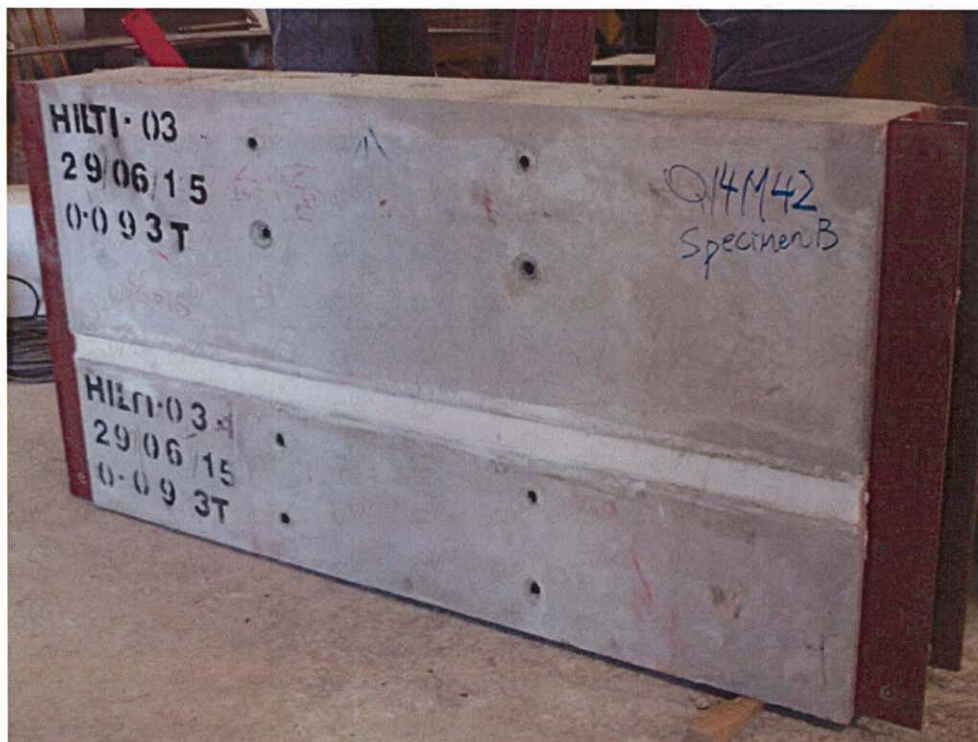
Photo 5: Specimen B after the test

The specimen complete the cycling test without deterioration observed during the test.
