Hilti CP 601S Firestop Silicone Sealant

Submission Folder

Elastomeric silicone sealant CP 601S

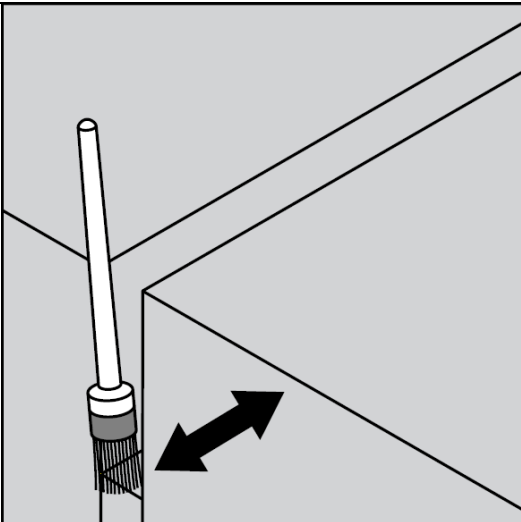
Setting Operation									
1	Clean the opening. Surfaces to which CP 601S will be applied should be cleaned of loose debris, dirt, oil, wax and grease. The surface should be moisture and frost free.

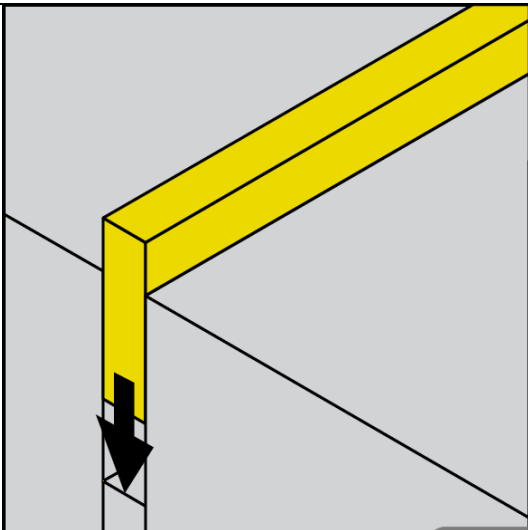
2	Insert fill of mineral wool or backing material (if required)

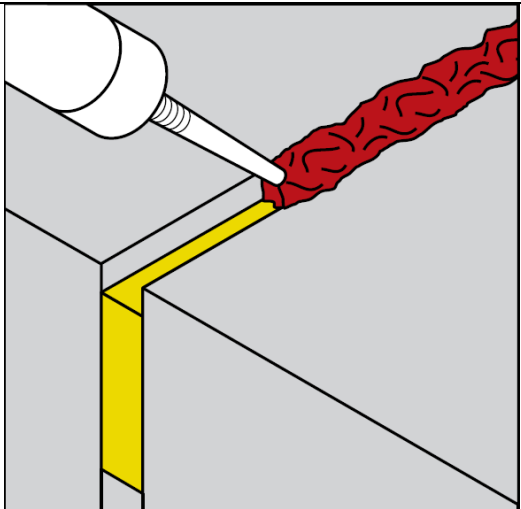
3	Apply CP 601S over the backing material . <table><tr><td>Joint width (mm)</td><td>0-15</td><td>16-100</td></tr><tr><td>Sealant thickness (mm)</td><td>6</td><td>15</td></tr></table>	Joint width (mm)	0-15	16-100	Sealant thickness (mm)	6	15

Joint width (mm)	0-15	16-100							
Sealant thickness (mm)	6	15

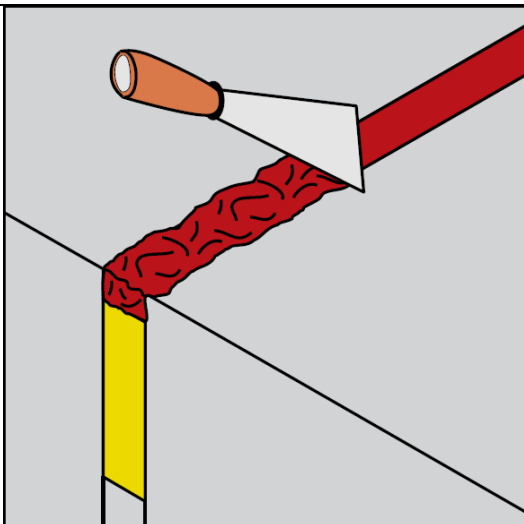
4	Smooth CP 601S using a trowel before the skin forms. It can only be removed mechanically once it is cured.

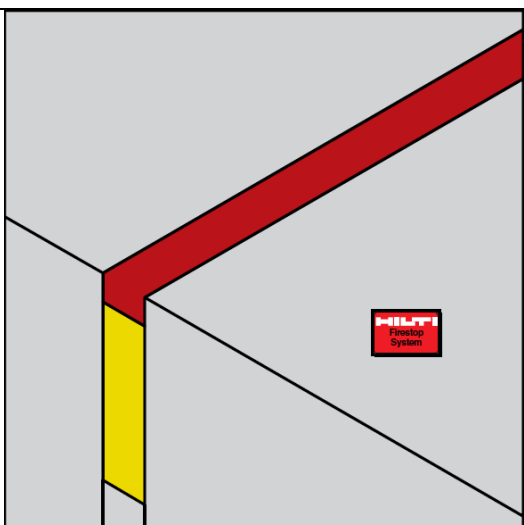
5	For maintenance reasons, a penetration seal would be permanently marked with an identification plate. In such a case mark the identification plate and fasten it in a visible position next to the seal

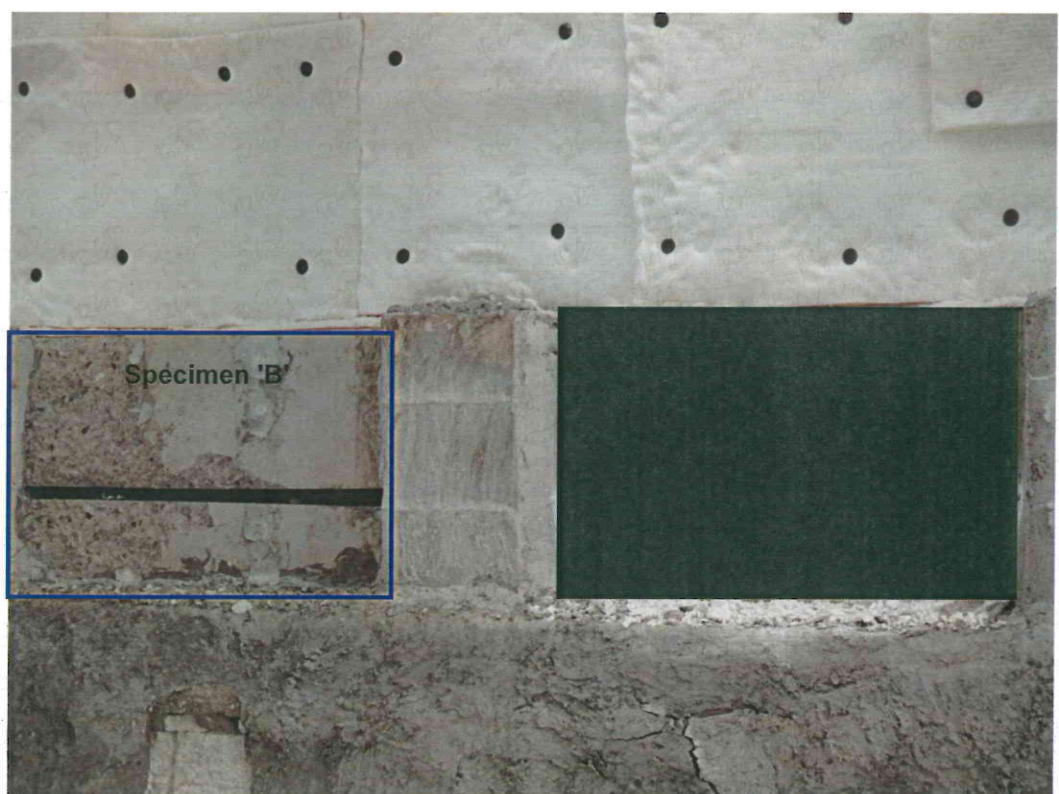
Photo 6: The exposed face of the specimens after the test.

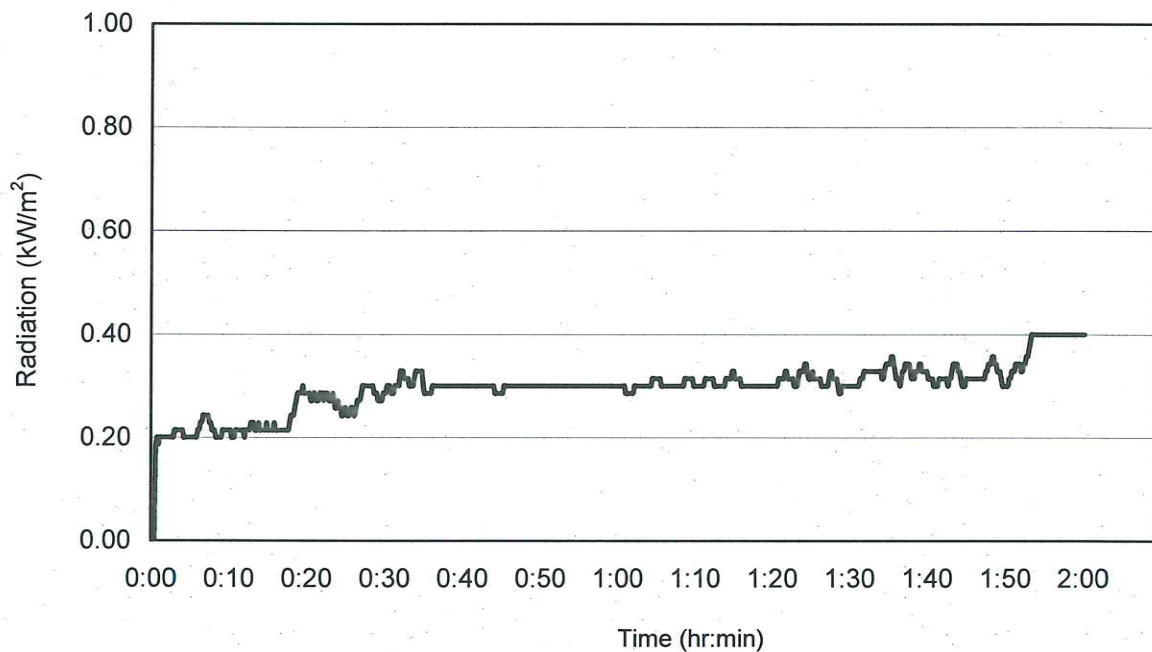
A radiometer placed at 1,000 mm away from the unexposed surface to measure the radiation of unexposed surface of the specimens.

Figure 6 – Radiation.

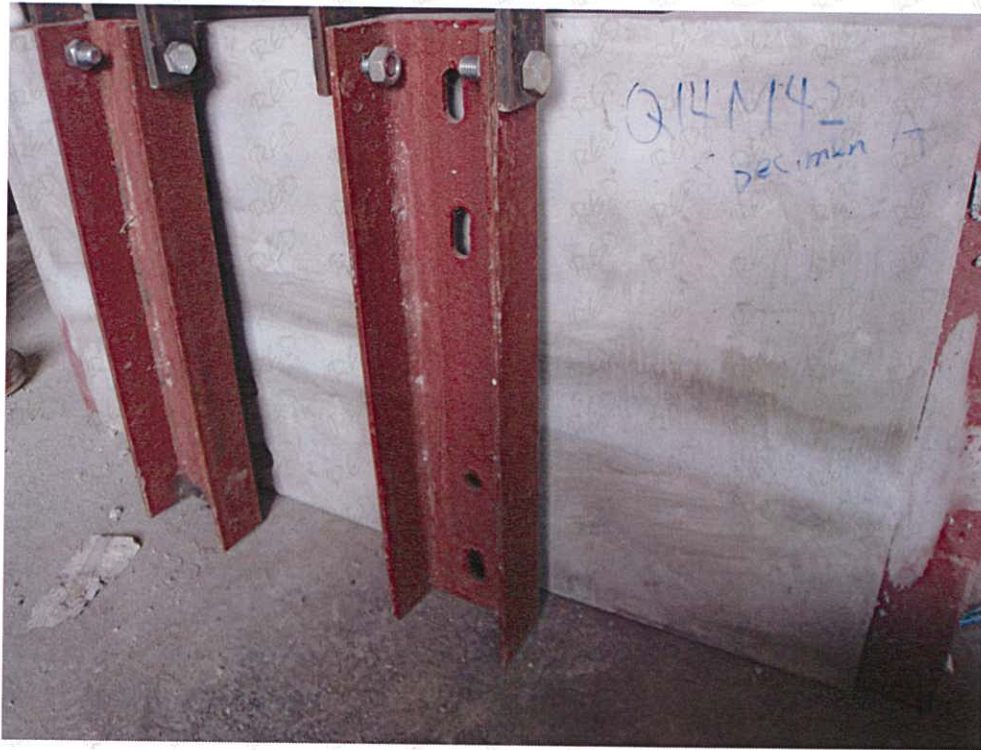
Photo 2: Specimen A before the test
