# **Hilti FS-ONE MAX High-Performance**

# **Intumescent Firestop Sealant Submission Folder**

# FIRE RESISTANCE TEST IN ACCORDANCE WITH BS 476: PART 20: 1987

On 7 nos. of Penetration Systems (Specimens '2a', '2b', '3', '6', '8', '9' and '10')

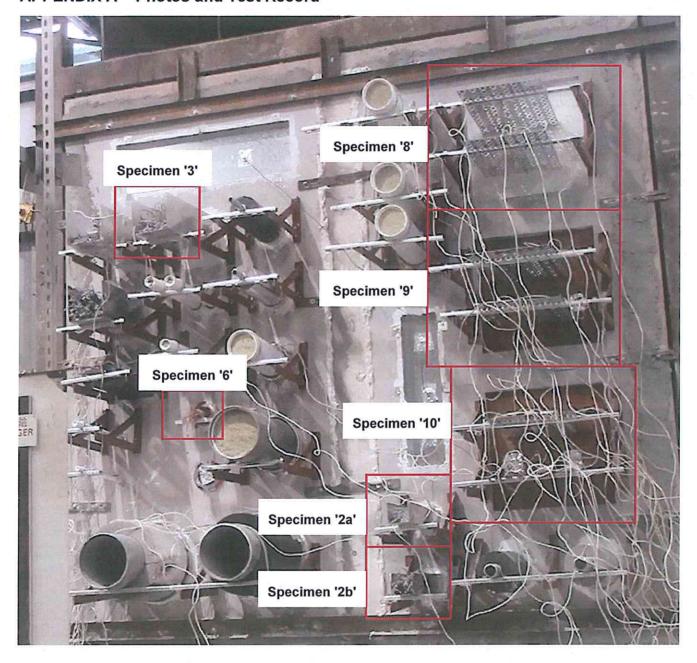
Photo 1: The unexposed face of the specimens before the test.

Note: In this test report, only specimens '2a', '2b', '3', '6', '8', '9' and '10' were considered.

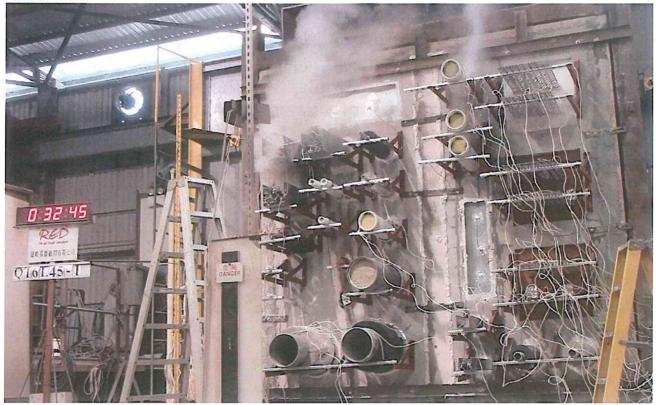
Photo 2: The unexposed face of the specimens after a heating period of 32 minutes.

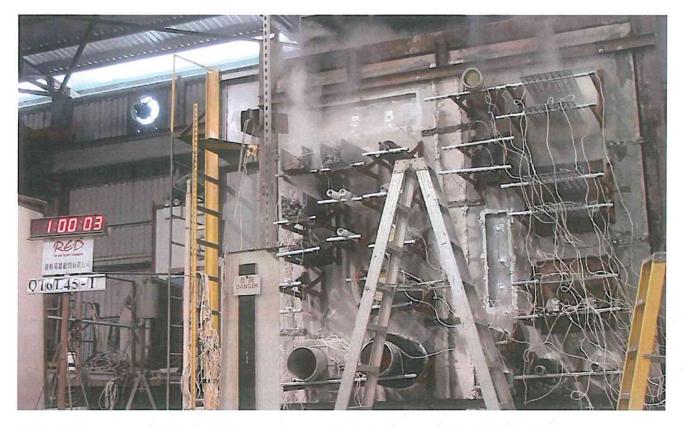
Photo 3: The unexposed face of the specimens after a heating period of 60 minutes.

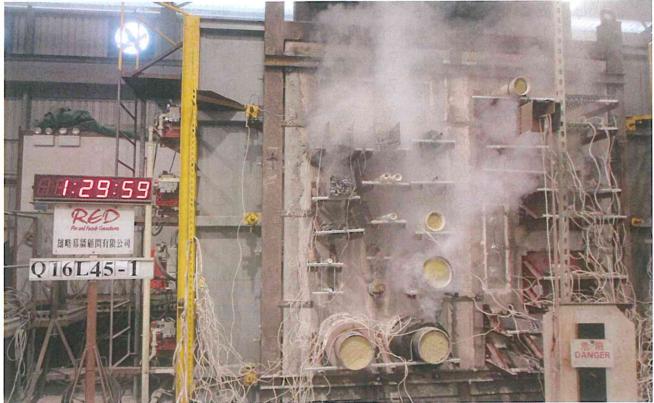
Photo 4: The unexposed face of the specimens after a heating period of 89 minutes.

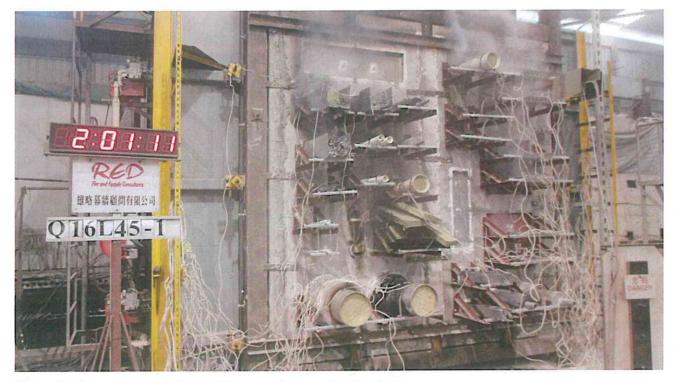
Photo 5: The unexposed face of the specimens after the test.

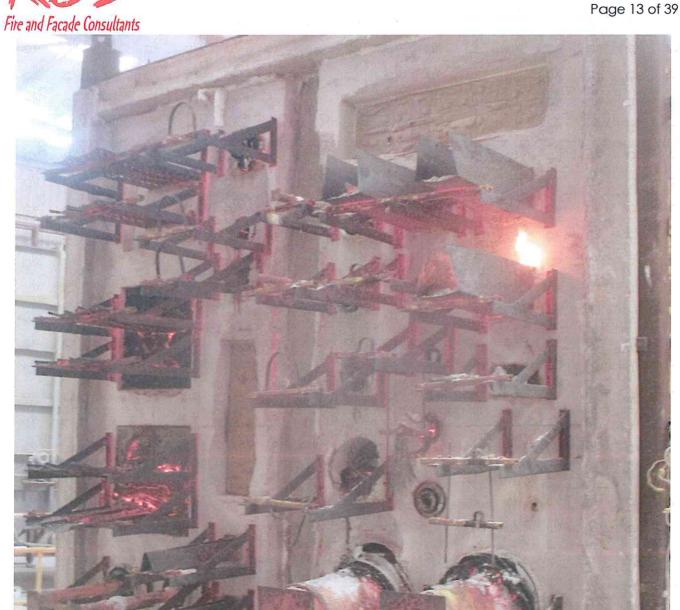
Photo 6: The exposed face of the specimens after the test.

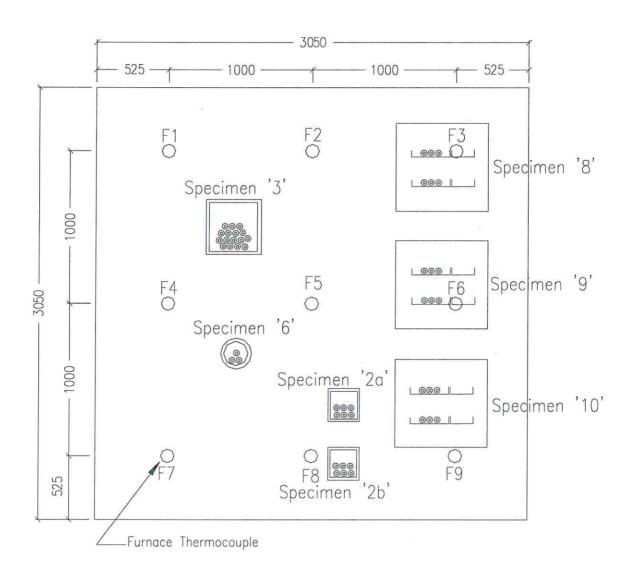
Figure 1 – Locations and reference numbers of furnace thermocouples. (This figure is not to scale and all dimensions are in millimetres.)

Nine (9) 'type K' thermocouples to monitor the temperature of the furnace, which were kept at 100 mm

from the exposed face of the specimen (see Figure 1).

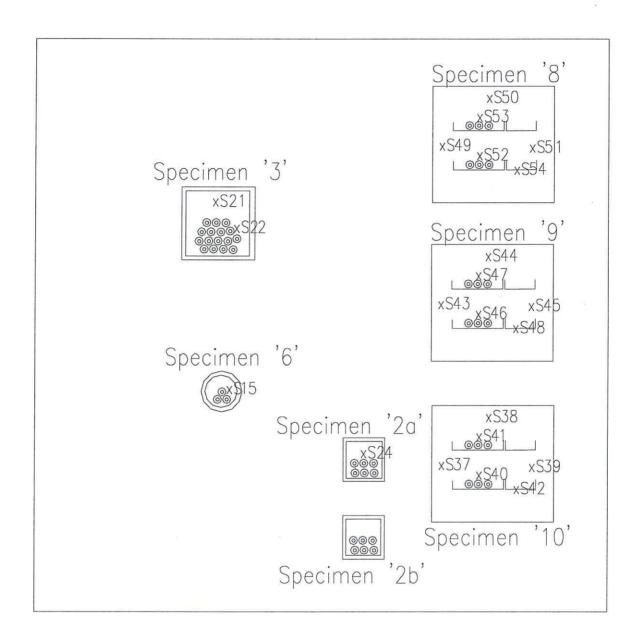
Figure 2 – Locations and reference number of thermocouples to monitor the temperature of unexposed surface of the specimens.

(This figure is not to scale.)

Thermocouples S15, S21, S22 and S24 were fixed for additional information only.

Twenty-two (22) 'type K' thermocouples to monitor the temperature of the unexposed face of the

specimens (see Figure 2).

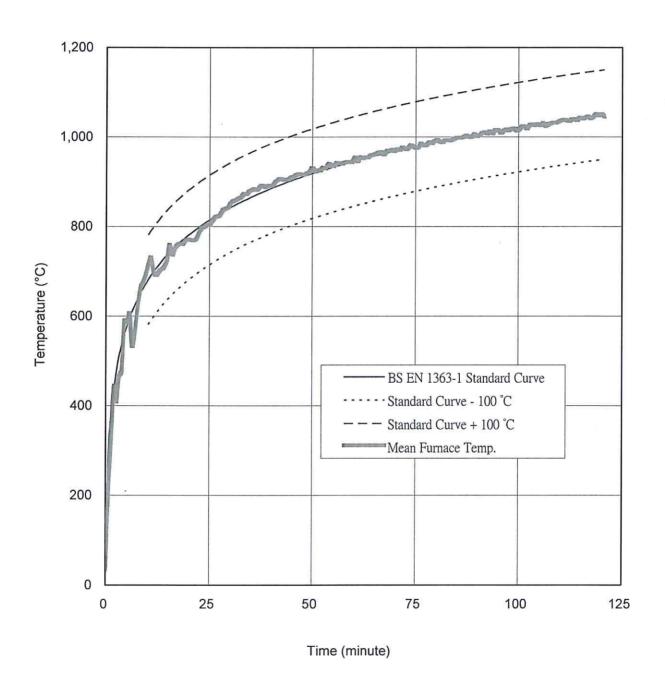
Figure 3 – Mean furnace temperature.

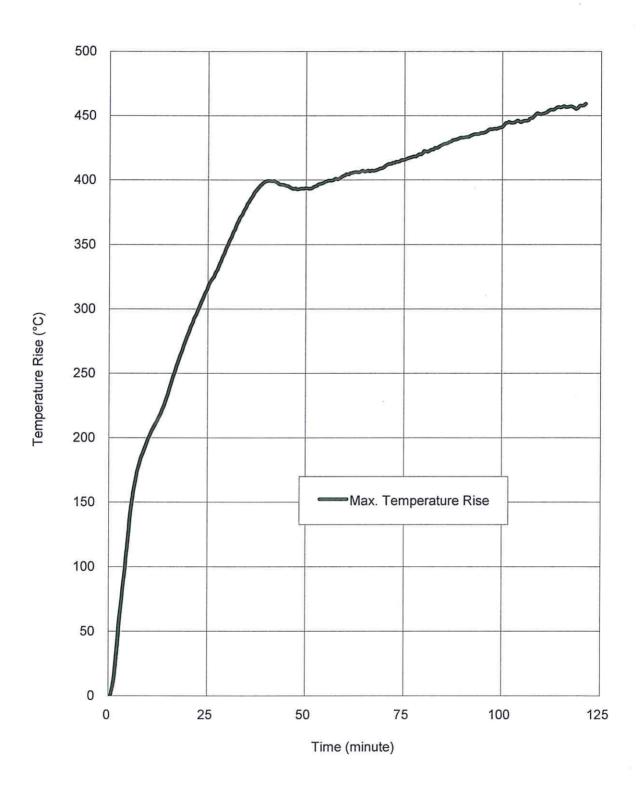
Figure 4 – Temperature rises of unexposed surface of specimen '2a'.

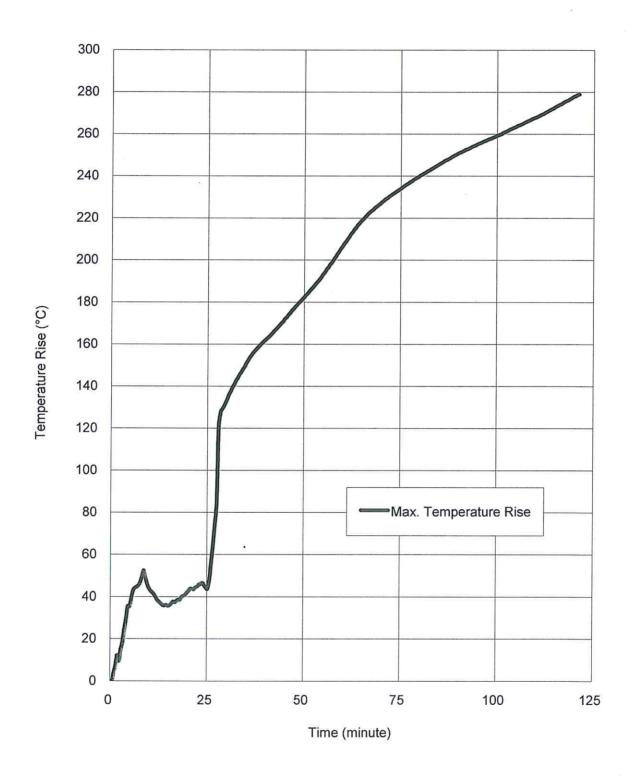
Figure 5 - Temperature rises of unexposed surface of specimen '3'.

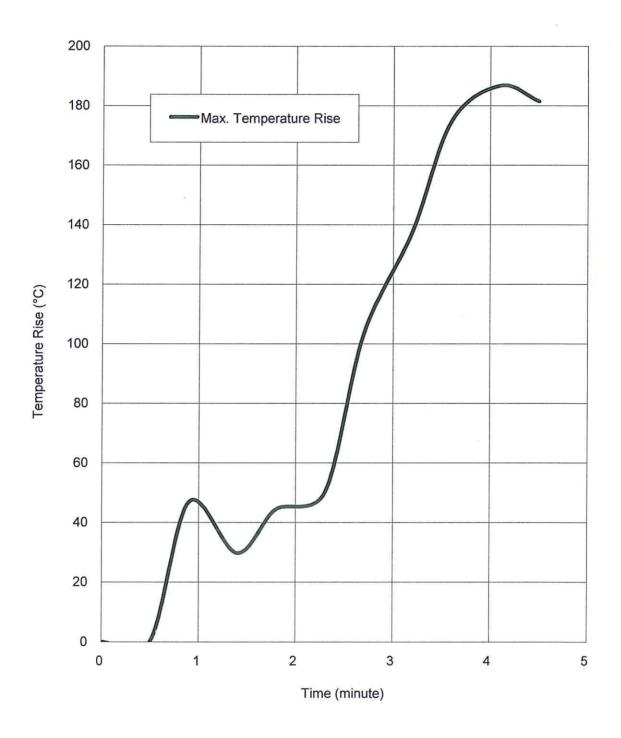
Figure 6 - Temperature rises of unexposed surface of specimen '6'.

Note: Thermocouple S15 was detached after a heating period of 5 minutes.

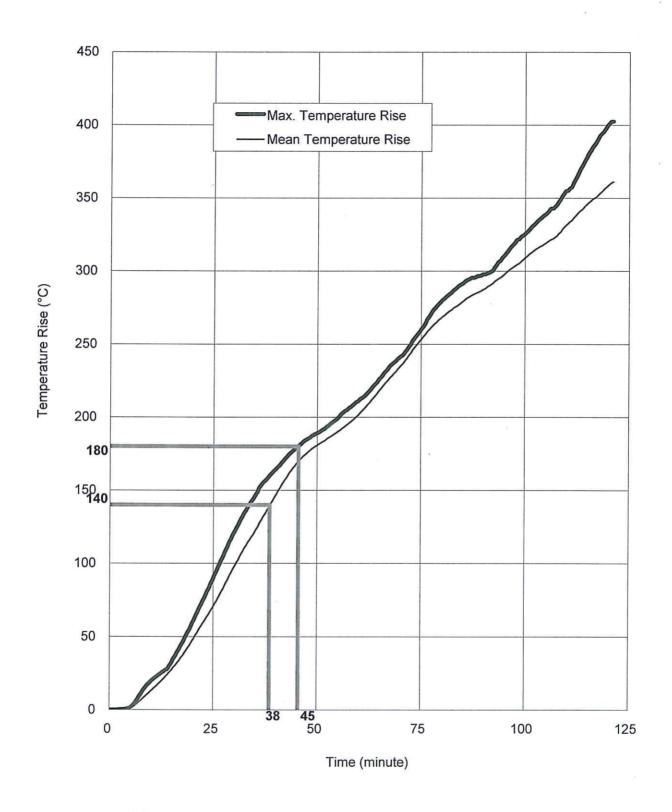
Figure 7 - Temperature rises of unexposed surface of specimen '8'.

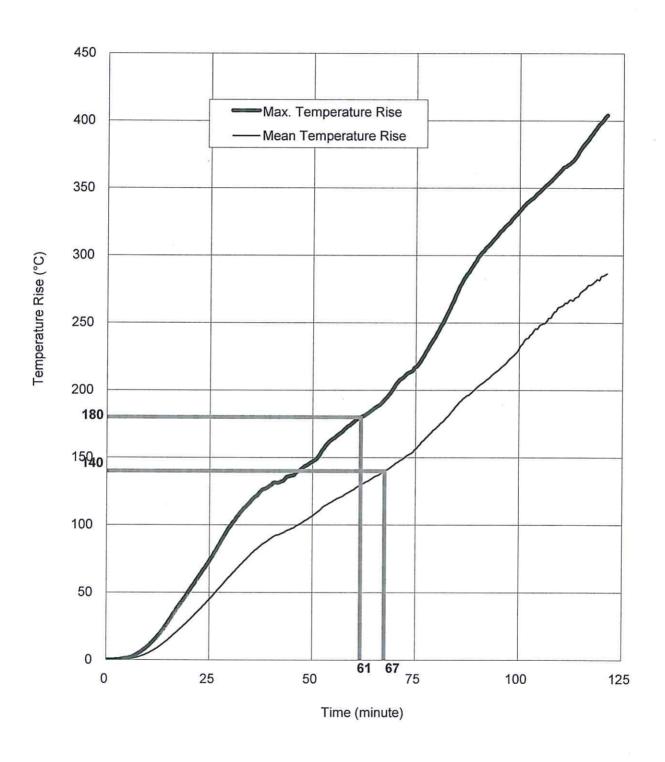
Figure 8 – Temperature rises of unexposed surface of specimen '9'.

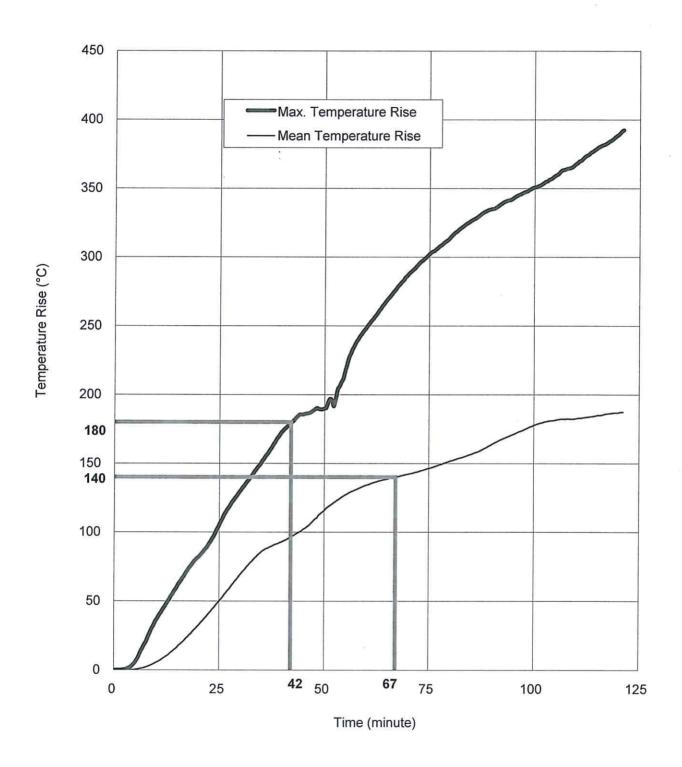
Figure 9 - Temperature rises of unexposed surface of specimen '10'.

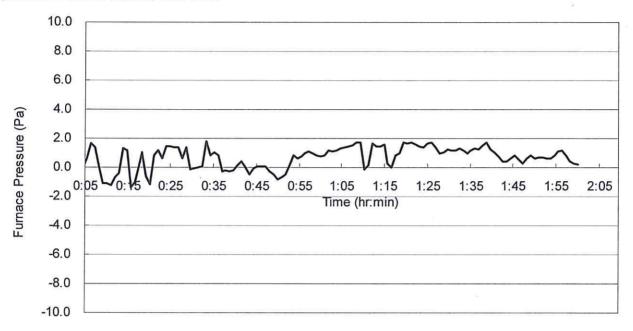
After the first 5 minutes of the test, the furnace pressure was maintained at  $0 \pm 2$  Pa relative to atmosphere, at 1,000 mm from the notional floor level.

Figure 10 - Furnace pressure.

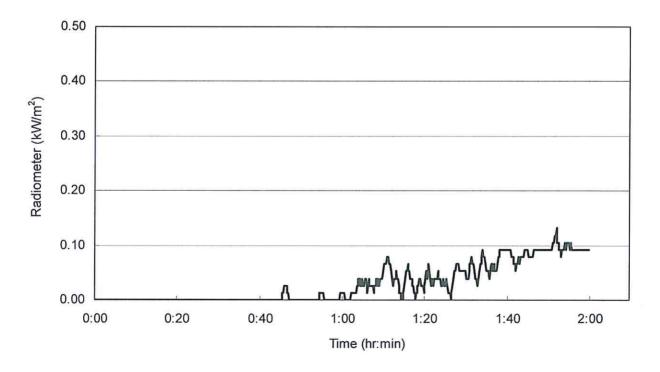
A radiometer placed at 1,000 mm away from the unexposed surface to measure the radiation of unexposed surface of the specimens.

Figure 11 - Radiation.

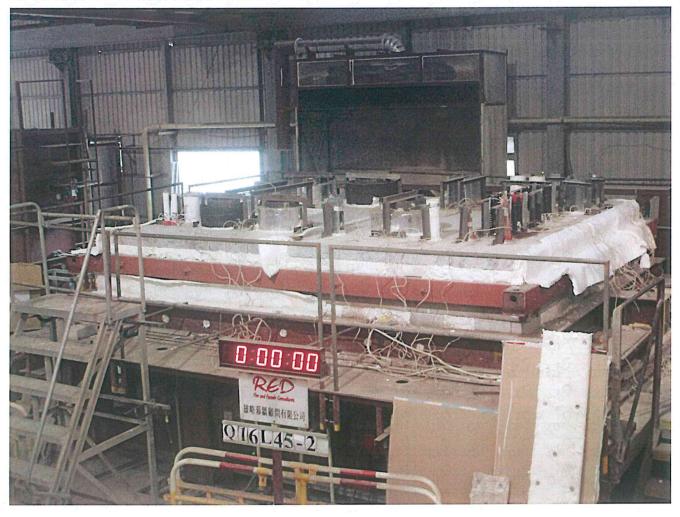
Photo 1: The unexposed face of the specimens before the test.

Note: In this test report, only specimens '1', '3a', '3b' and '6' were considered.

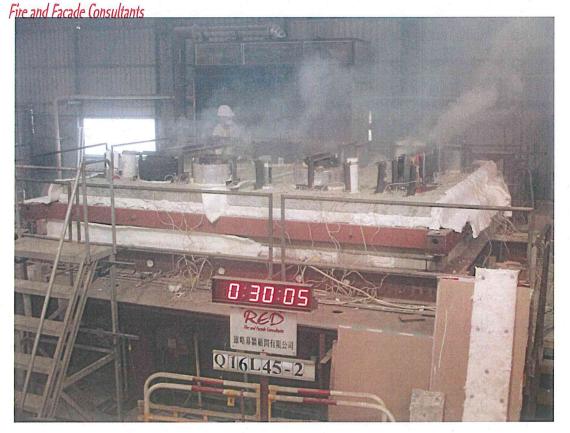
Photo 2: The unexposed face of the specimens after a heating period of 30 minutes.

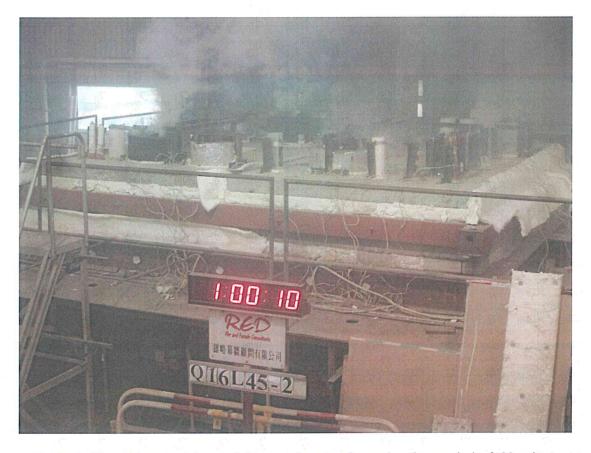
Photo 3: The unexposed face of the specimens after a heating period of 60 minutes.

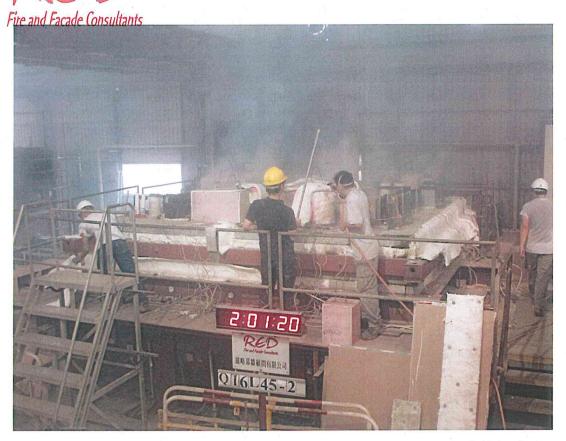
Photo 4: The unexposed face of the specimens after a heating period of 121 minutes.

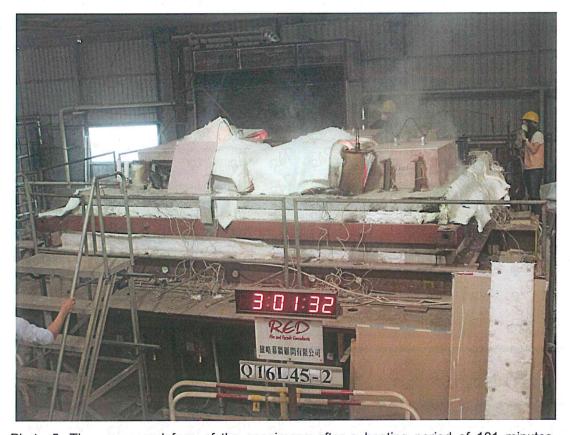
Photo 5: The unexposed face of the specimens after a heating period of 181 minutes.

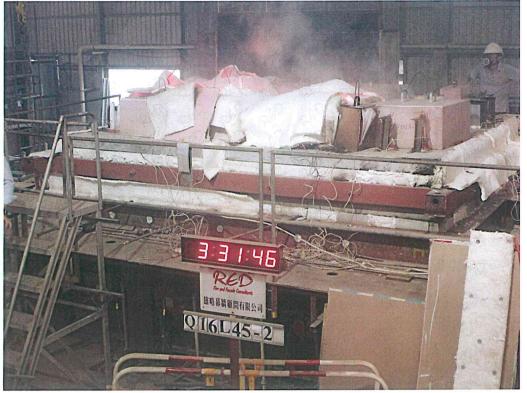
Photo 6: The unexposed face of the specimens after a heating period of 211 minutes.

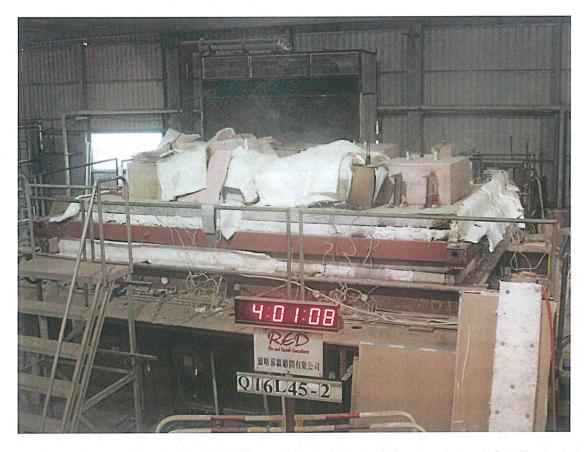
Photo 7: The unexposed face of the specimens after the test.

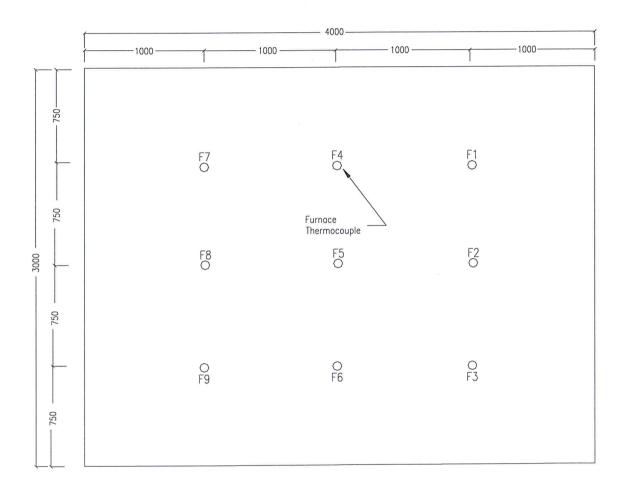
Figure 1 – Locations and reference numbers of furnace thermocouples. (This figure is not to scale and all dimensions are in millimetres.)

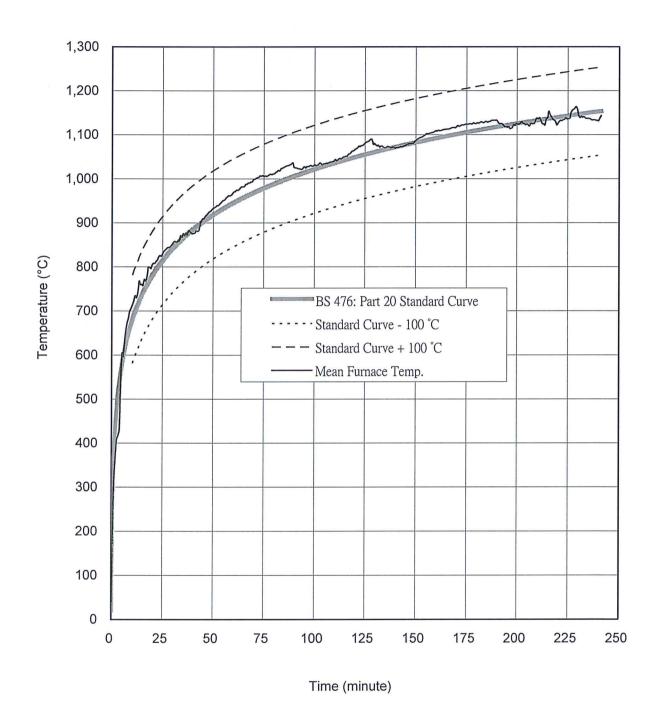
Figure 3 – Mean furnace temperature.

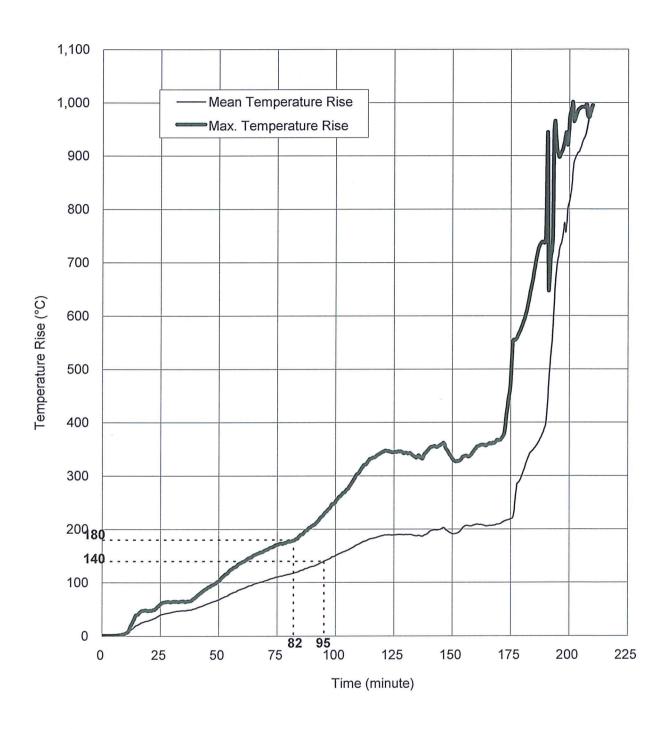
Figure 4 – Temperature rises of unexposed surface of specimen '1'.

Note: Thermocouples S49, S52 and S54 detached after a heating period of 207 minutes.

Thermocouple S50, S51 and S53 detached after a heating period of 190, 201 and 209 minutes respectively.

Sustained flaming was observed on specimen '1' after a heating period of 174 minutes.

174.30	U	Sustained flaming was observed from specimen '1'. Integrity failed.
177.21	U	Specimen '1' was covered by fire rated board with ceramic fibre blank as
		requested by the test sponsor. Integrity failed.

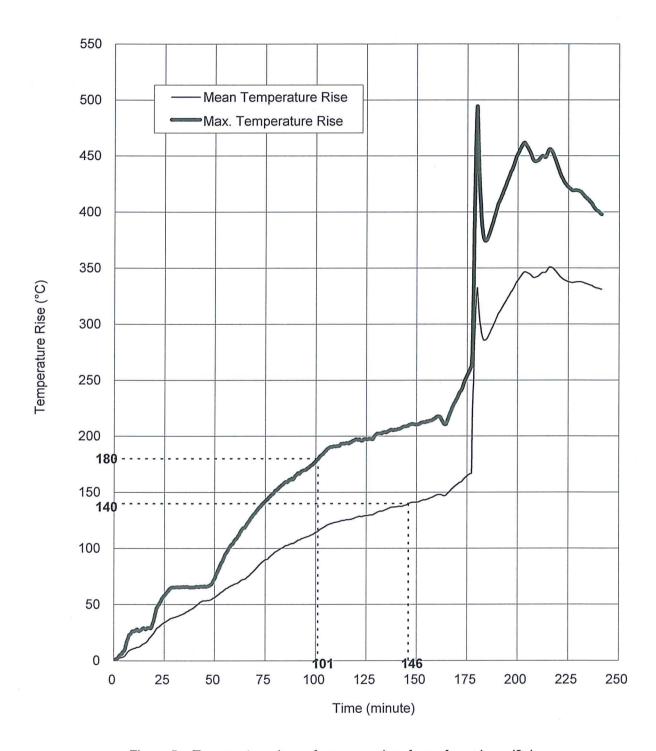
Figure 5 – Temperature rises of unexposed surface of specimen '3a'.

Note: Thermocouple S11 detached after a heating period of 177 minutes.

Sustained flaming was observed on specimen '3a' after a heating period of 177 minutes.

177.31	U	Sustained flaming was observed from specimen '3a'. Integrity failed.
179.49	U	Specimen '3a' was covered by fire rated board with ceramic fibre blank as
		requested by the test sponsor. Integrity failed.

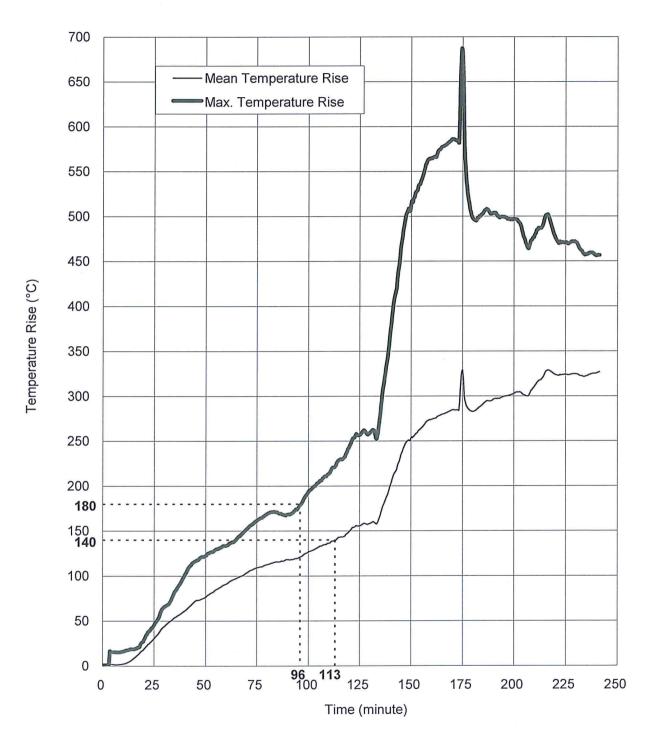
Figure 6 – Temperature rises of unexposed surface of specimen '3b'.

Sustained flaming was observed on specimen '3b' after a heating period of 173 minutes.

173.20	U	Sustained flaming was observed from specimen '3b'. Integrity failed.
174.24	U	Specimen '3b' was covered by fire rated board with ceramic fibre blank as
		requested by the test sponsor. Integrity failed.

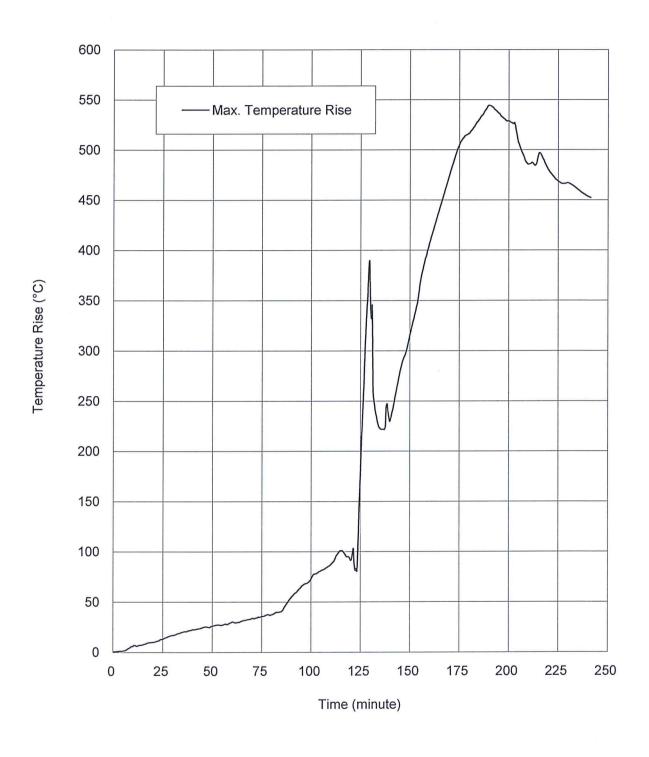
Figure 7 – Temperature rises of unexposed surface of specimen '6'. (for additional information only)

Sustained flaming was observed on specimen '6' after a heating period of 130 minutes.

120.00	U	Specimens '1', '3a', '3b' and '6' satisfied the integrity and insulation requirements
		performance.
130.10	U	Sustained flaming was observed from specimen '6'. Integrity failed.

131.06	U	Specimen '6' was covered by fire rated board with ceramic fibre blank as
		requested by the test sponsor. Integrity failed.
150.00	U	Specimens '1', '3a' and '3b' satisfied the integrity and insulation requirements
	,	performance.

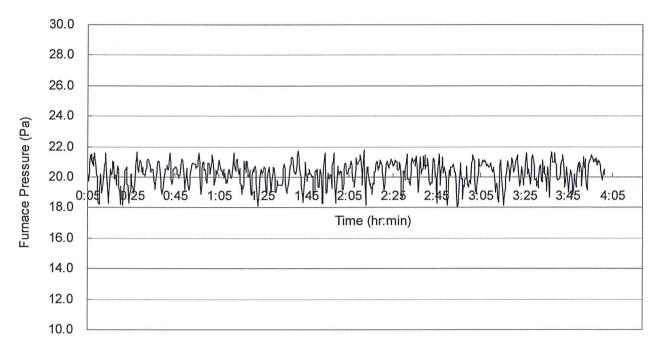
After the first 5 minutes of the test, the furnace pressure was maintained at 20  $\pm$  2 Pa relative to atmosphere, at 100 mm from the exposed side of specimen.

Figure 10 - Furnace pressure.
