Hilti CP636 Firestop Mortar

Submission Folder

Firestop mortar CP 636

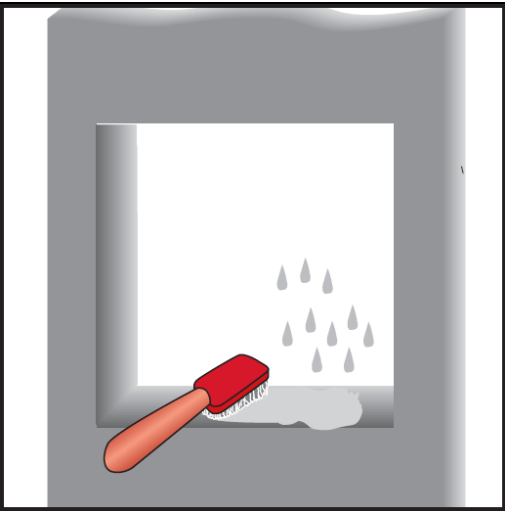
| Setting Operation | | |
|---|---|--|
| 1 | Clean and premoisten the surfaces. Cables and cable supporting structures must be installed in compliance with local building and electrical standards. | |

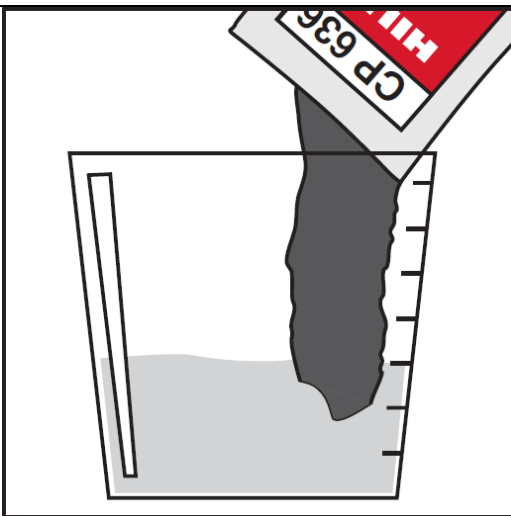
| Setting Operation | | |
|---|---|--|
| 2 | Add mortar to water in a ratio of about 3:1 by volume (mortar to water). Stir the mixture thoroughly with, for example, a Hilti TE-MP/ TE-18M paddle. The mix ratio of water to CP 636 determines the desired consistency. Do not use any other binders or additives/ aggregates | |

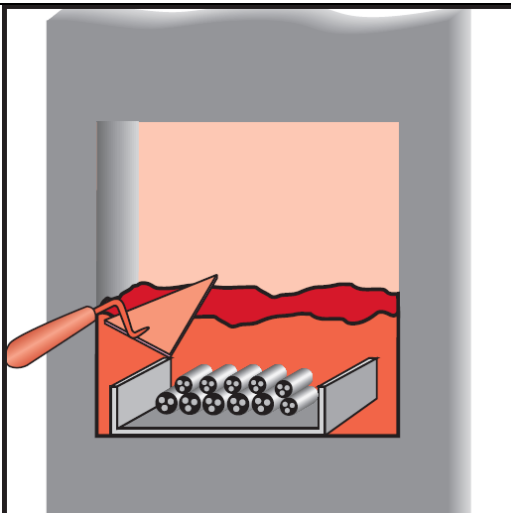
| Setting Operation | | |
|---|---|--|
| 3 | <u>Method 1</u> : Apply mixed mortar in the opening using a trowel or a pump and compact it. Make sure all gaps and spaces are completely filled and closed. <u>Method 2</u> : The penetration sealing system shall be constructed on 50 mm thick of mineral wool with 35mm thick Hilti CP 636 Fire Prevention Mortar on both sides. | |

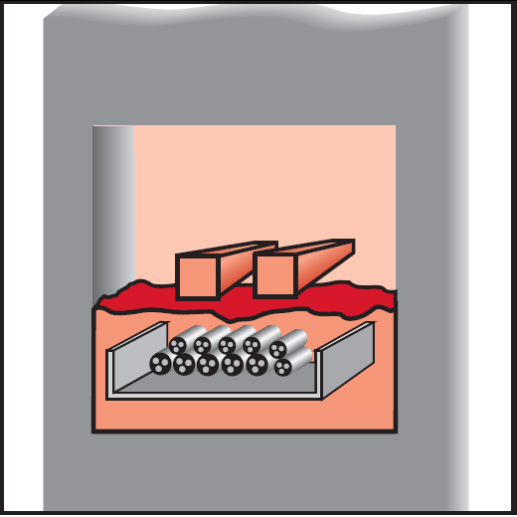
| 4 | <p>CP 611A can be used in conjunction with mortar. In such case, apply CP 611A to the cables over a width of approx. 30mm and 5mm thick. Fill the gap between cables with CP 611A. Application of the mortar can be continued immediately after CP 611A has been applied.</p> | |

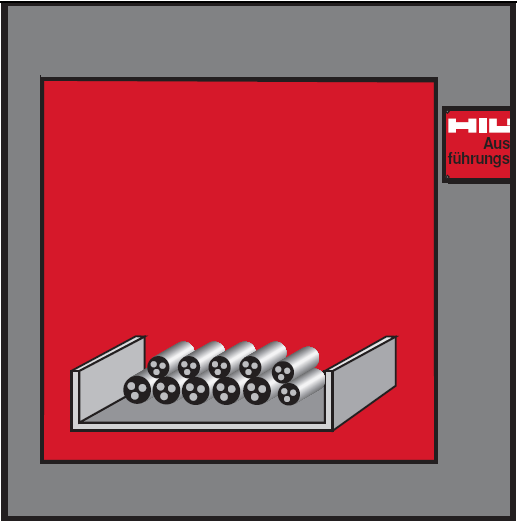
| 5 | <p>For maintenance reasons, a penetration seal could be permanently marked with an identification plate. In such a case, mark the identification plate and fasten it in a visible position next to the seal.</p> | |
