Hilti CP643N Firestop Collar

Submission Folder

Firestop collar CP 643 N

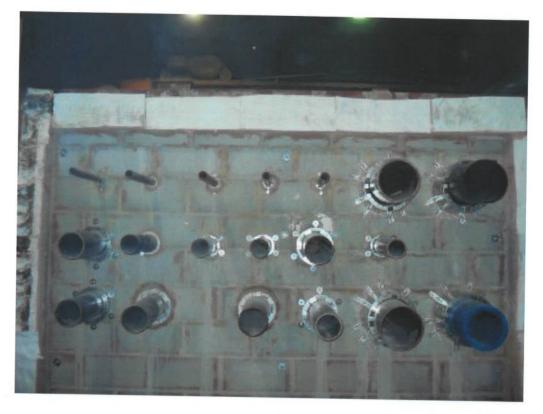
Plate 1	:	Showing the exposed face of the assembly prior to the test
Plate 2	:	Showing the unexposed face of the assembly prior to the test
Plate 3	:	Showing the unexposed face of the assembly during the test
Plate 4	:	Showing the unexposed face of the assembly during the test
Plate 5	:	Showing the unexposed face of the assembly during the test
Plate 6	:	Showing the unexposed face of the assembly during the test
Plate 7	:	Showing the unexposed face of the assembly during the test
Plate 8	:	Showing the unexposed face of the assembly during the test
Plate 9	:	Showing the unexposed face of the assembly during the test
Plate 10	:	Showing the exposed face of the assembly directly after the test

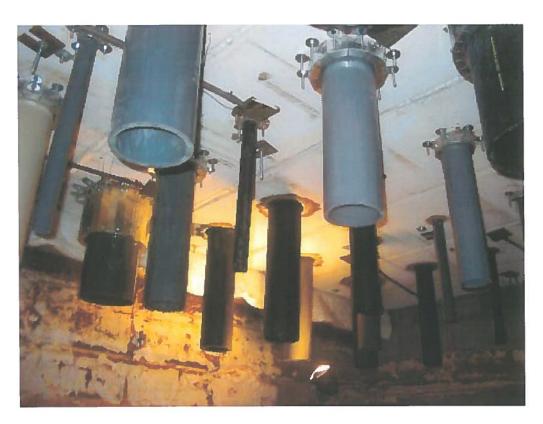
Plate 1

Plate 1:	Showing the exposed face of the specimens prior to the test
Plate 2 :	Showing the exposed face of the specimens prior to the test
Plate 3 :	Showing the exposed face of the specimens prior to the test
Plate 4 :	Showing the unexposed face of the specimens during the test
Plate 5 :	Showing the unexposed face of the specimens during the test
Plate 6 :	Showing the unexposed face of the specimens during the test
Plate 7 :	Showing the unexposed face of the specimens during the test
Plate 8 :	Showing the unexposed face of the specimens during the test
Plate 9 :	Showing the unexposed face of the specimens during the test
Plate 10:	Showing the unexposed face of the specimens directly after the test
