Hilti CP643N Firestop Collar

Submission Folder

The Fire Resistance Performance of Hilti Pipe Penetration Sealing Systems

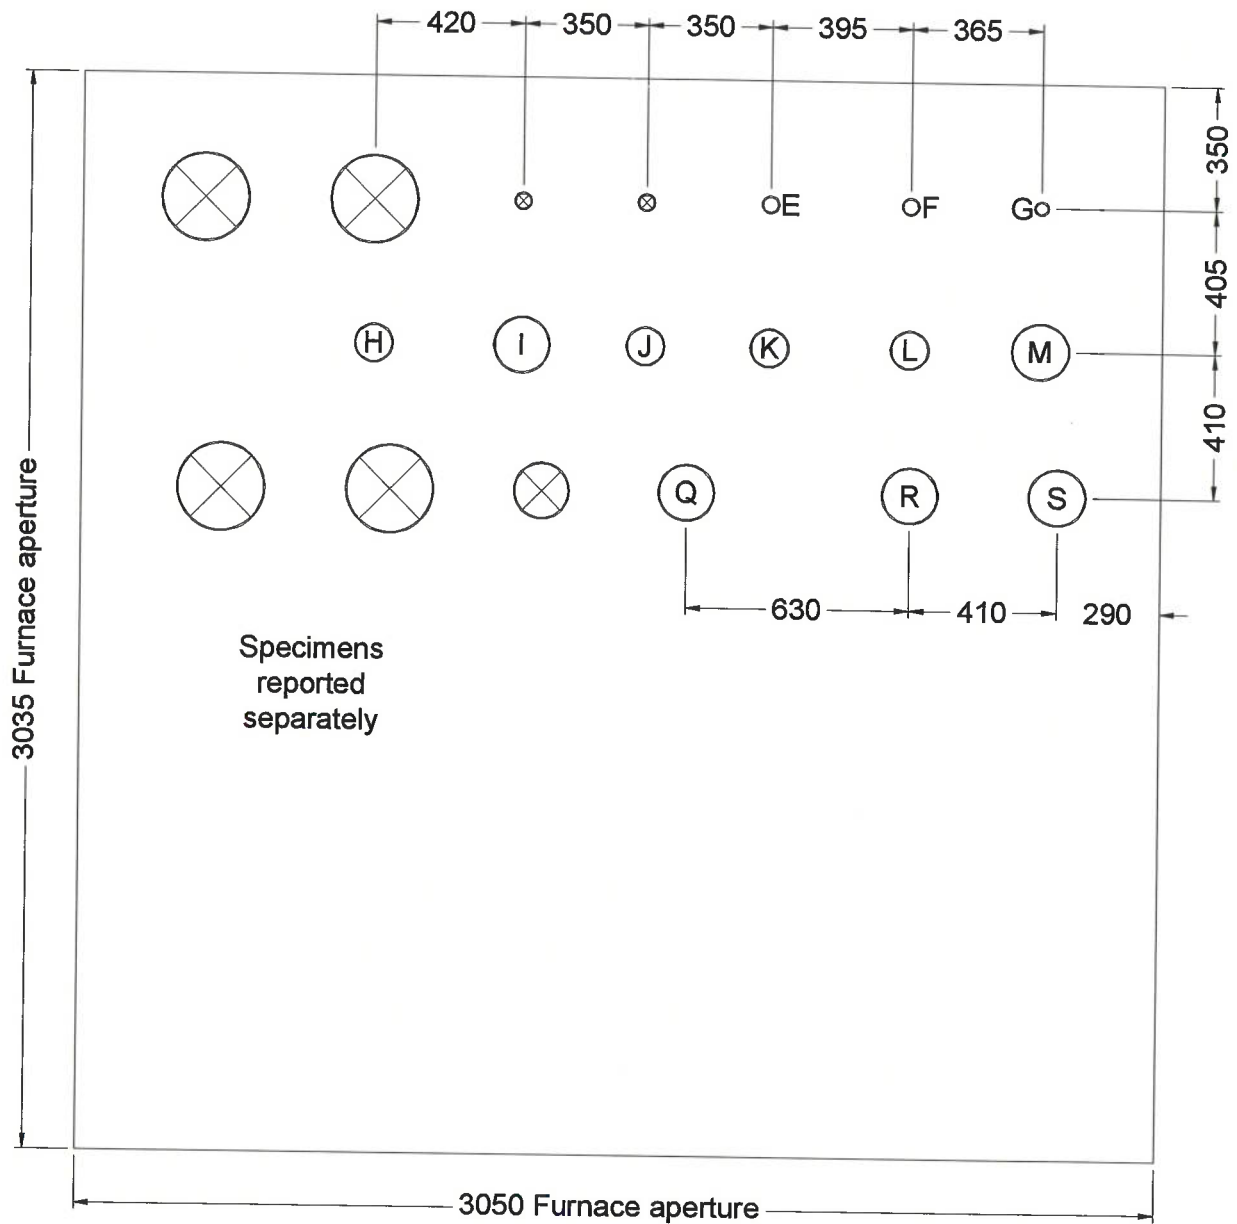
FIGURE 1

GENERAL ELEVATION
OF UNEXPOSED FACE
