# Hilti CFS-B Firestop Bandage

## Submission Folder

## Firestop bandage CFS-B

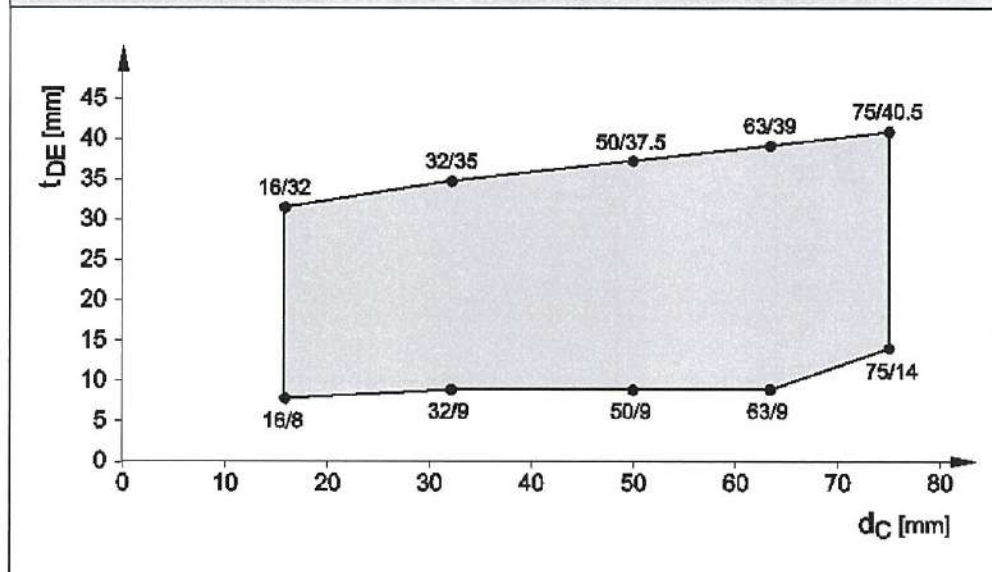
**Aluminium Composite Pipes, U/C, flexible wall  $\geq 100$  mm - EI 60**  
**All specimens listed**  
**Graph shows approved insulation thickness ( $t_{DE}$ ) at certain pipe diameter ( $\varnothing d_C$ )**

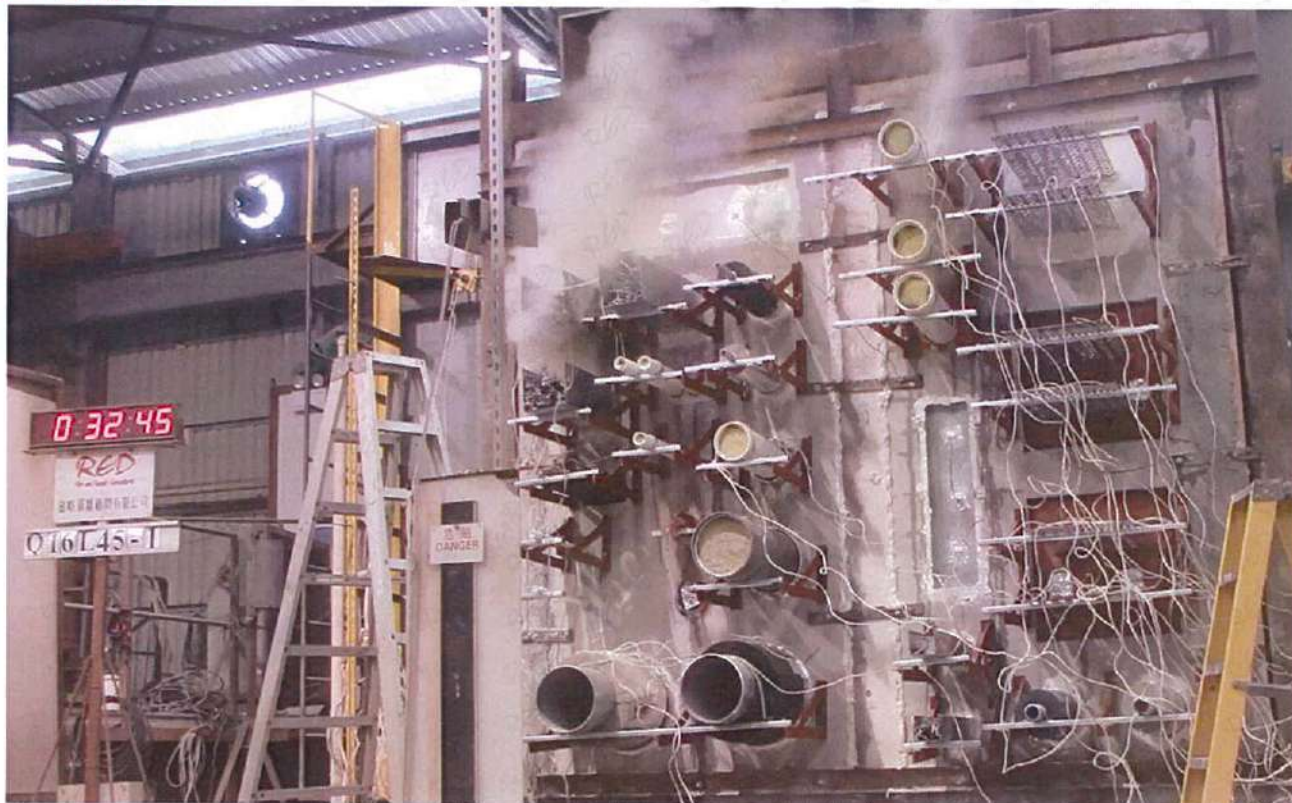
Photo 2: The unexposed face of the specimens after a heating period of 32 minutes.

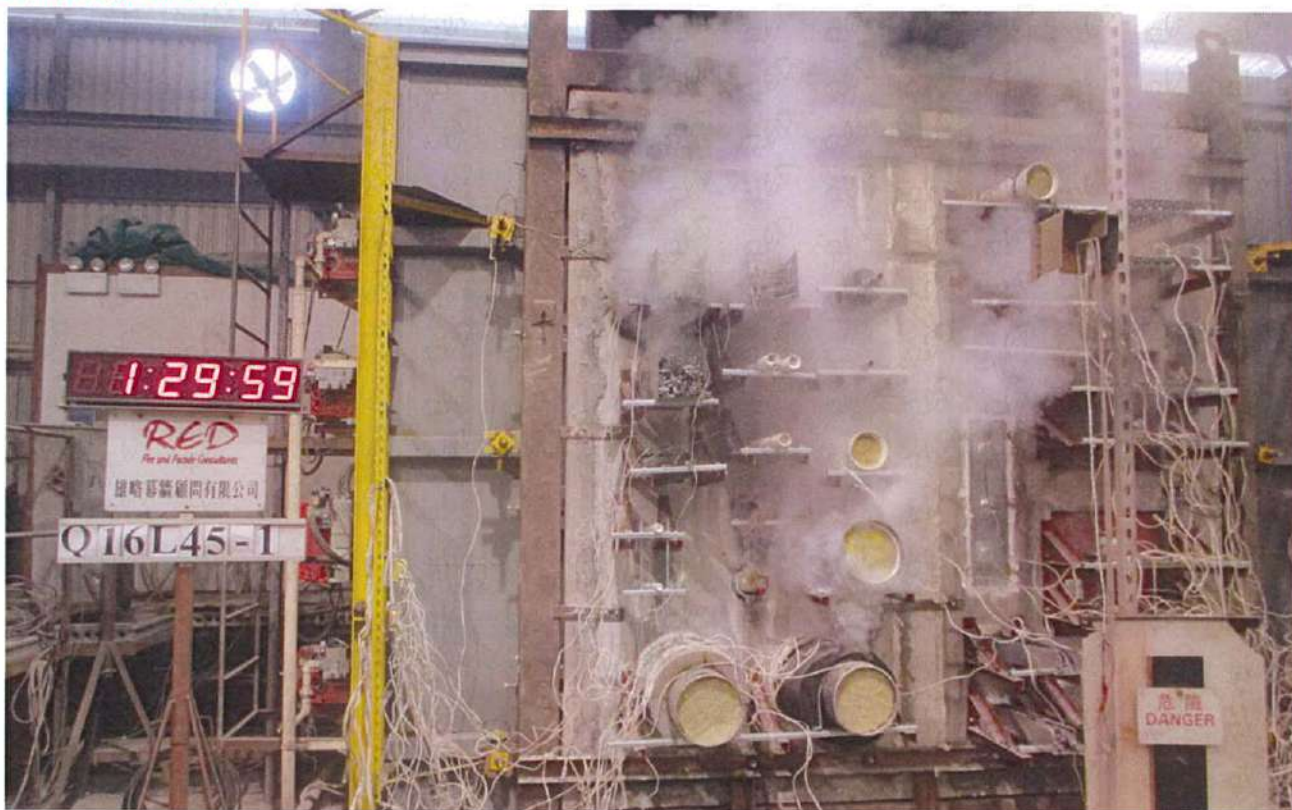
Photo 4: The unexposed face of the specimens after a heating period of 89 minutes.

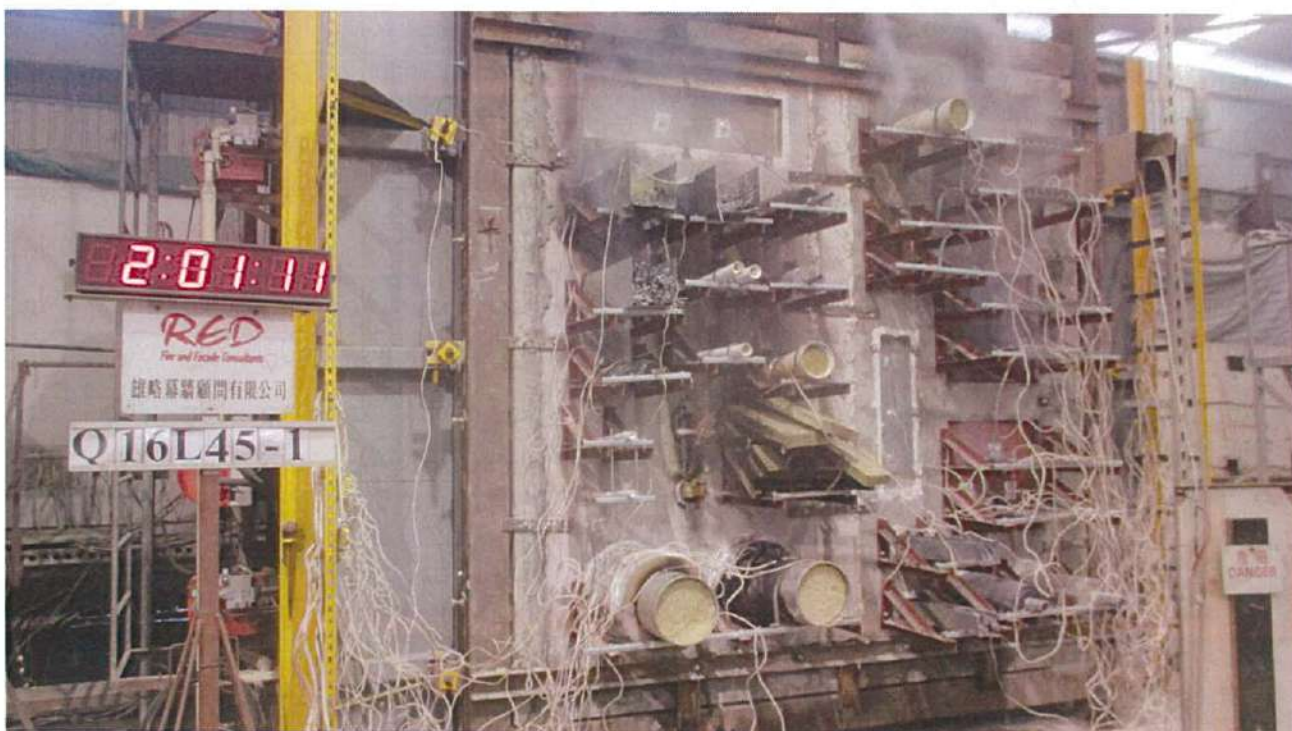
Photo 5: The unexposed face of the specimens after the test.

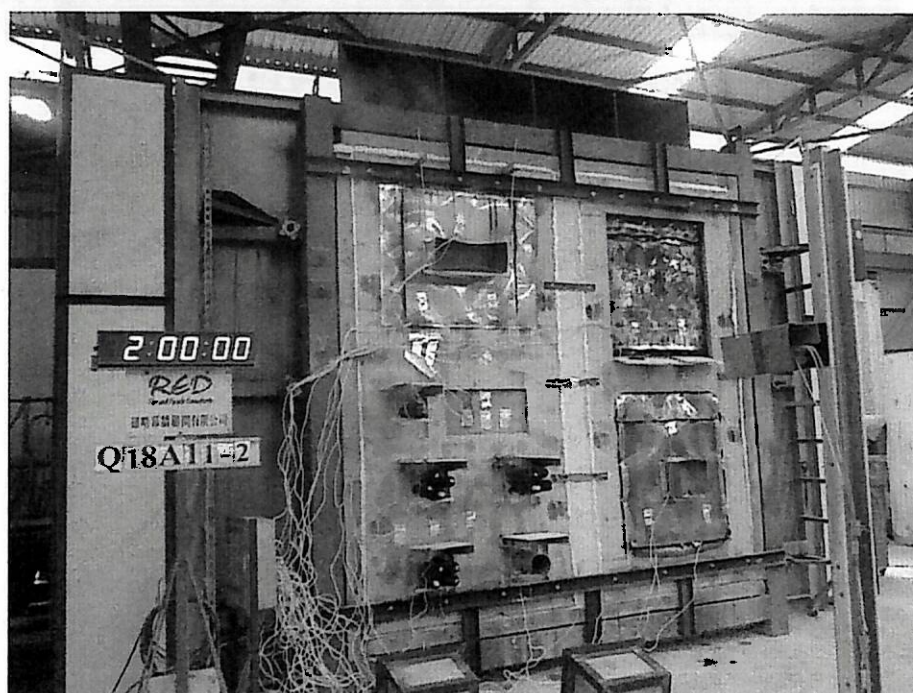
Photo 4: The unexposed face of the specimens after a heating period of 120 minutes.

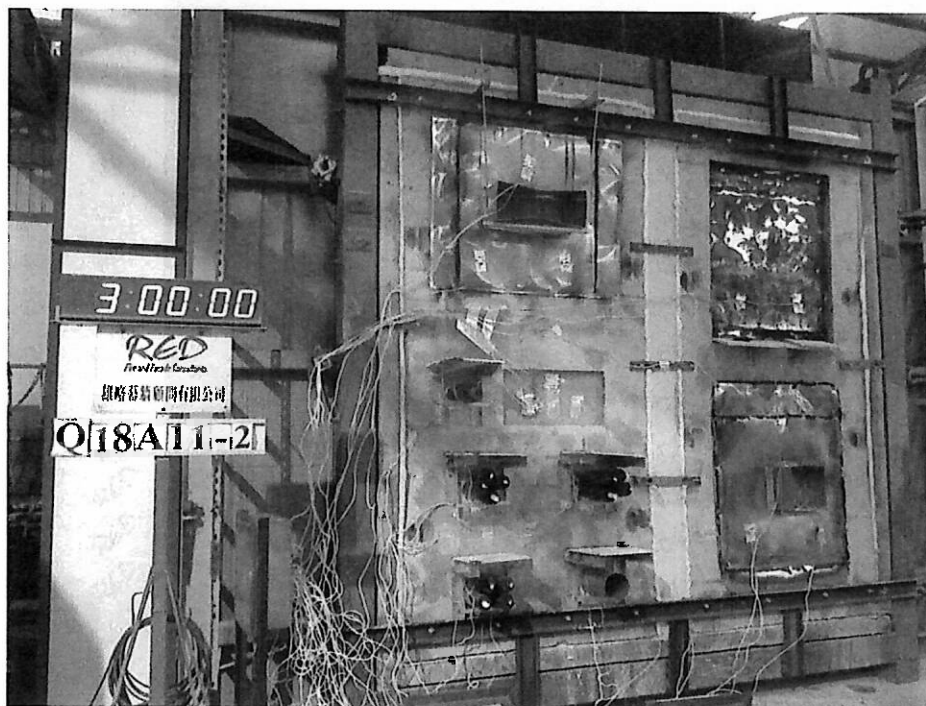
Photo 5: The unexposed face of the specimens after a heating period of 180 minutes.

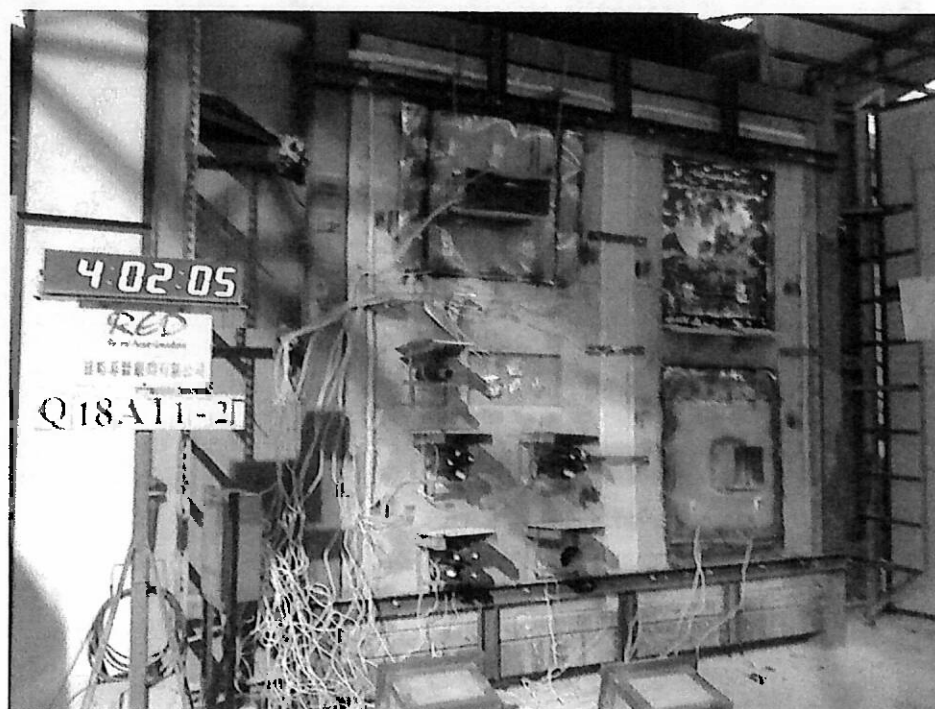
Photo 6: The unexposed face of the specimens after the test.
